INDOOR AIR QUALITY ASSESSMENT

Dighton Public Library 375 Main Street Dighton, Massachusetts

Prepared by:
Massachusetts Department of Public Health
Bureau of Environmental Health Assessment
Emergency Response/Indoor Air Quality Program
October 2003

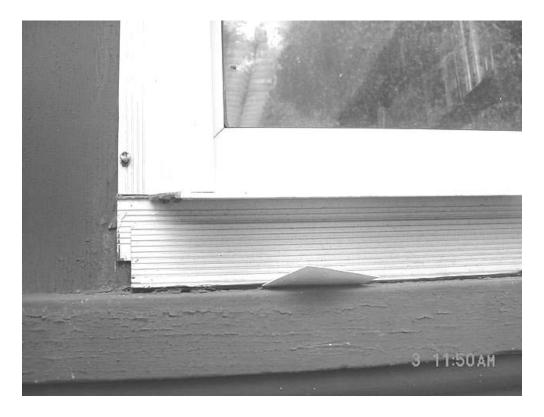
Temperature measurements ranged from 71° F to 72° F, which were within the BEHA recommended comfort range. The BEHA recommends that indoor air temperatures be maintained in a range of 70° F to 78° F in order to provide for the comfort of building occupants. In many cases concerning indoor air quality, fluctuations of temperature in occupied spaces are typically experienced, even in a building with an adequate fresh air supply. Temperature control complaints were reported by library staff. Often times, temperature control is difficult, especially in an old building without a mechanical ventilation system. In addition, spaces were observed around window frames (Picture 1), which can allow drafts to penetrate, leading to temperature/comfort complaints.

Spaces around Window Frames, Paper Inserted to Show Depth

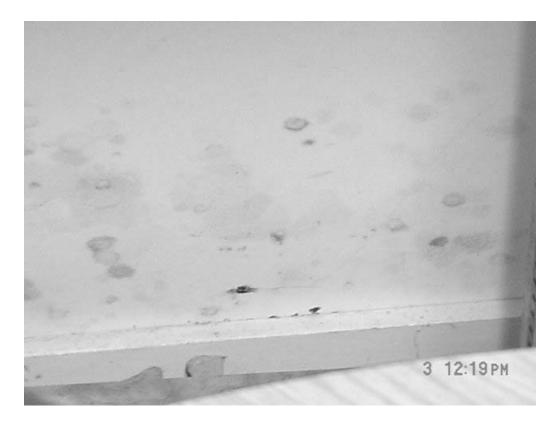
Mold growth was observed on the GW in the homework center, near the floor and in the bulkhead stairwell (Pictures 2 and 3). Mold growth and water damage was noted on wooden baseboard and trim (Picture 4). Like other porous materials, GW that is wetted

Mold Colonies (Dark Stains) on GW in Homework Center

Remove and replace any mold contaminated/water damaged GW and wooden baseboard/trim. This measure will remove actively growing mold colonies that may be present. Remove mold contaminated materials in a manner consistent with recommendations found in "Mold Remediation in Schools and Commercial Buildings" published by the US Environmental Protection Agency (US EPA, 2001). Copies of this document can be downloaded from the US EPA website at: http://www.epa.gov/iaq/molds/mold_remediation.html. Removing the water-damaged GW and wooden trim will also provide maintenance personnel with the opportunity to observe conditions within the wall cavity and determine whether any signs of water penetration through breaches of the building envelope exist.

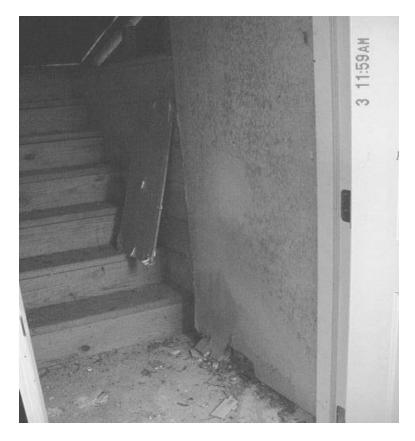
Mold Colonies (Dark Stains) on GW in Bulkhead Stairway in Children's Area

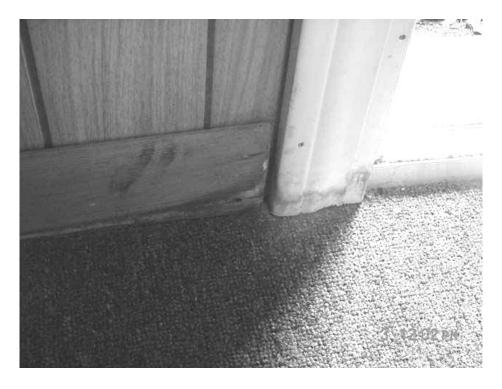
Water Damage/Mold Growth on Wooden Trim and Baseboard in Basement Children's Area

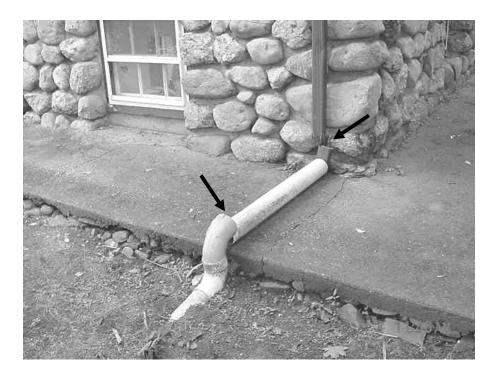
- Damaged/dislodged gutters and downspouts were observed at the rear of the building (Picture 5).
- Heavy moss growth was seen along the front tarmac of the building, indicating an area of chronic water accumulation. The water appears to roll off the peaked roof over the front entrance, which is not equipped with a gutter system (Picture 6).
- The tarmac was cracked and had plant growth between the foundation and tarmac in a number of areas (Picture 11). The growth of roots along exterior walls can hold moisture and eventually lead to cracks and/or fissures in the foundation below ground level.
- The wooden bulkhead located at the rear of the building was damaged (Picture 7 and 8). Spaces were also noted around flashing and in masonry around this

Broken/Dislodged Gutter and Downspout

- 3. Consider repairing/replacing damaged wooden window frames to prevent water penetration. Replace broken windowpanes.
- 4. Repair drainage system shown in Picture 5. Consider installing gutters/downspouts on the main entrance peaked roof to direct rainwater away from the building.

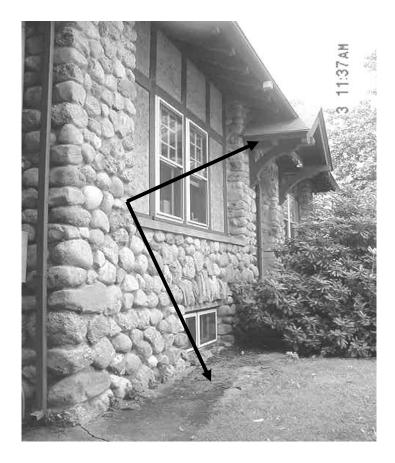
Area of Heavy Moss Growth below Peaked Roof Without Gutters

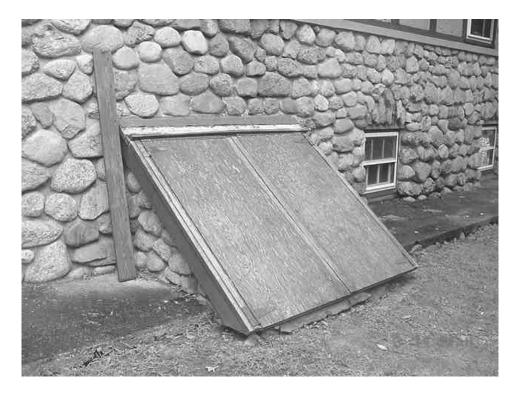
Damaged Wooden Bulkhead, Note Plank against Wall, Which is Part of the Bulkhead

- 5. Repair breaches in the building envelope including, cracks in walls and tarmac, missing/damaged flashing, and spaces around bulkheads. Consider replacing damaged wooden bulkhead with metal.

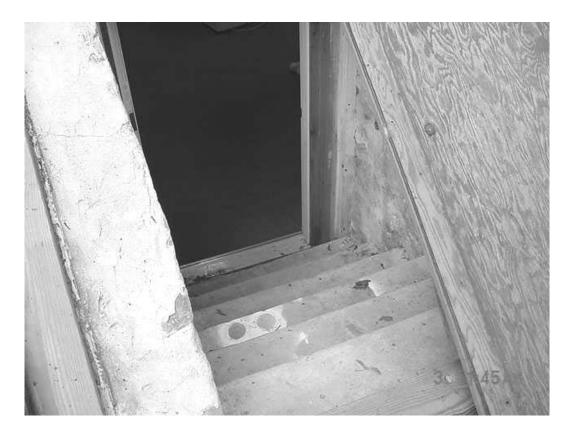
Bulkhead Stairwell Leading to Carpeted Children's Library, Also Site of Mold-Colonized GW in Picture 3

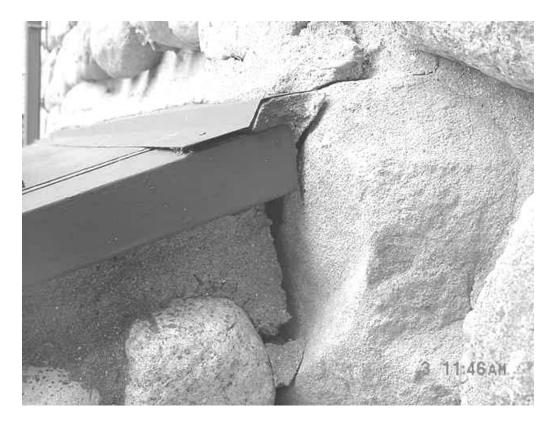
bulkhead, as well as around a metal bulkhead (Picture 9) leading to the carpeted children's library.

Spaces around Bulkhead Metal Flashing/Masonry

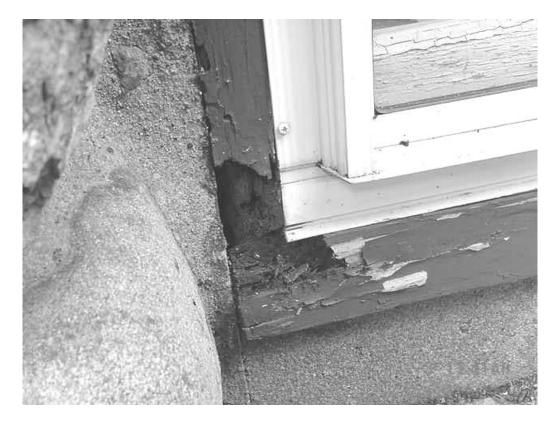
Rotted wooden windowsills and broken windowpanes were seen around the exterior of the building (Picture 10). As previously discussed, spaces around metal window frames, as well as missing/damaged caulking were observed.

Rotted Wooden Window Frame

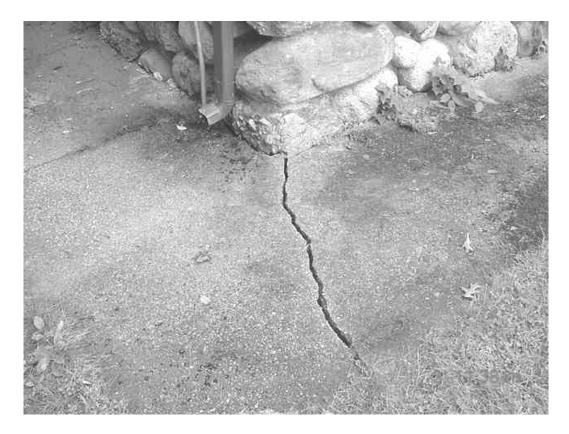
Crack in Tarmac/Plants growing between the Foundation and Tarmac

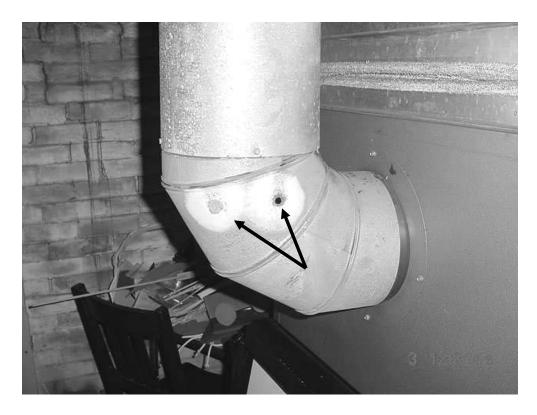
Spaces were observed beneath the door to the room in which the oil burner and fuel tank are located. Also noted in this area were holes in the ductwork for the oil burner (Picture 12). These breaches serve as a means of egress for fuel odors, fumes and particulates into the children's library.

Hole in Ductwork, Note Second Hole Filled

- 10. Install weather stripping along the top and sides and a door sweep beneath the boiler room door to prevent drafts and odors into the children's area.
- 11. Seal utility holes and openings in the restroom, as well as in the common wall shared between the boiler room and children's area to eliminate pathways for movement of odors into occupied areas.
- 12. Seal hole in ductwork for oil burner in Picture 12.
- 13. Consider installing a local exhaust fan in the restroom to remove excess moisture and odors.
- 14. Clean and maintain dehumidifiers as per the manufactures instructions.
- 15. For further building-wide evaluations and advice on maintaining public buildings, see the resource manual and other related indoor air quality documents located on the MDPH's website at http://www.state.ma.us/dph/beha/iaq/iaqhome.htm
